Heytesbury Underground Gas Storage (HUGS) Pipeline

Cultural Heritage Management Plan 18865

Heytesbury Underground Gas Storage (HUGS) Project

CHMP No. 18865

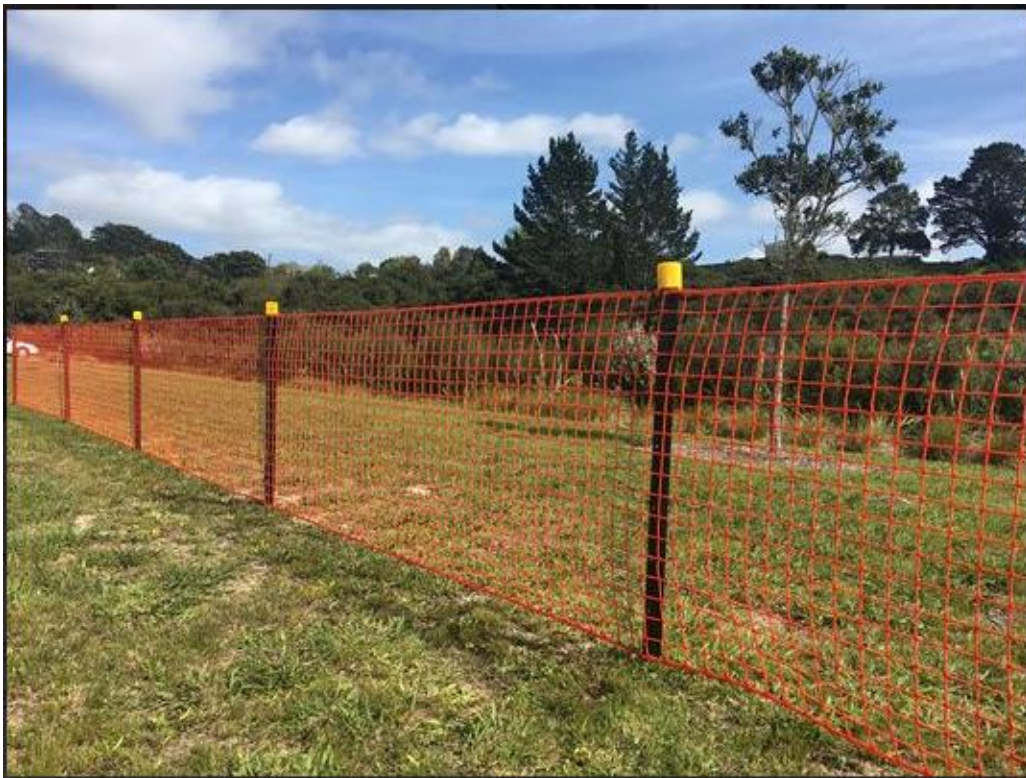
Figure 3: Type of fencing to be installed inside CROW fencing near VAHR 7420-0063.

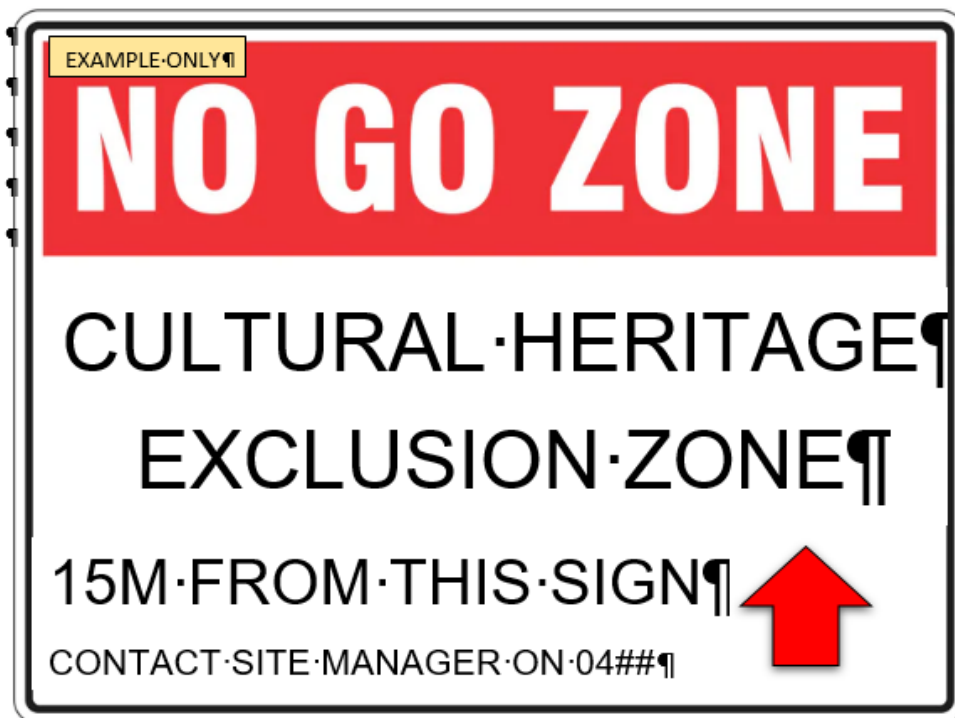
Figure 4: Indicative type of signage to be installed inside CROW fencing near VAHR 7420-0063.

4. No go signage must be clearly displayed at this location, on the temporary fencing similar to that included in Figure 4;
5. No machine/vehicle ground disturbing works can take place within 15m of VAHR 7420-0063, except for normal ground maintenance (i.e., Grass grazing by cattle, re-seeding, fertilising, etc) by the landowner and/or occupier.

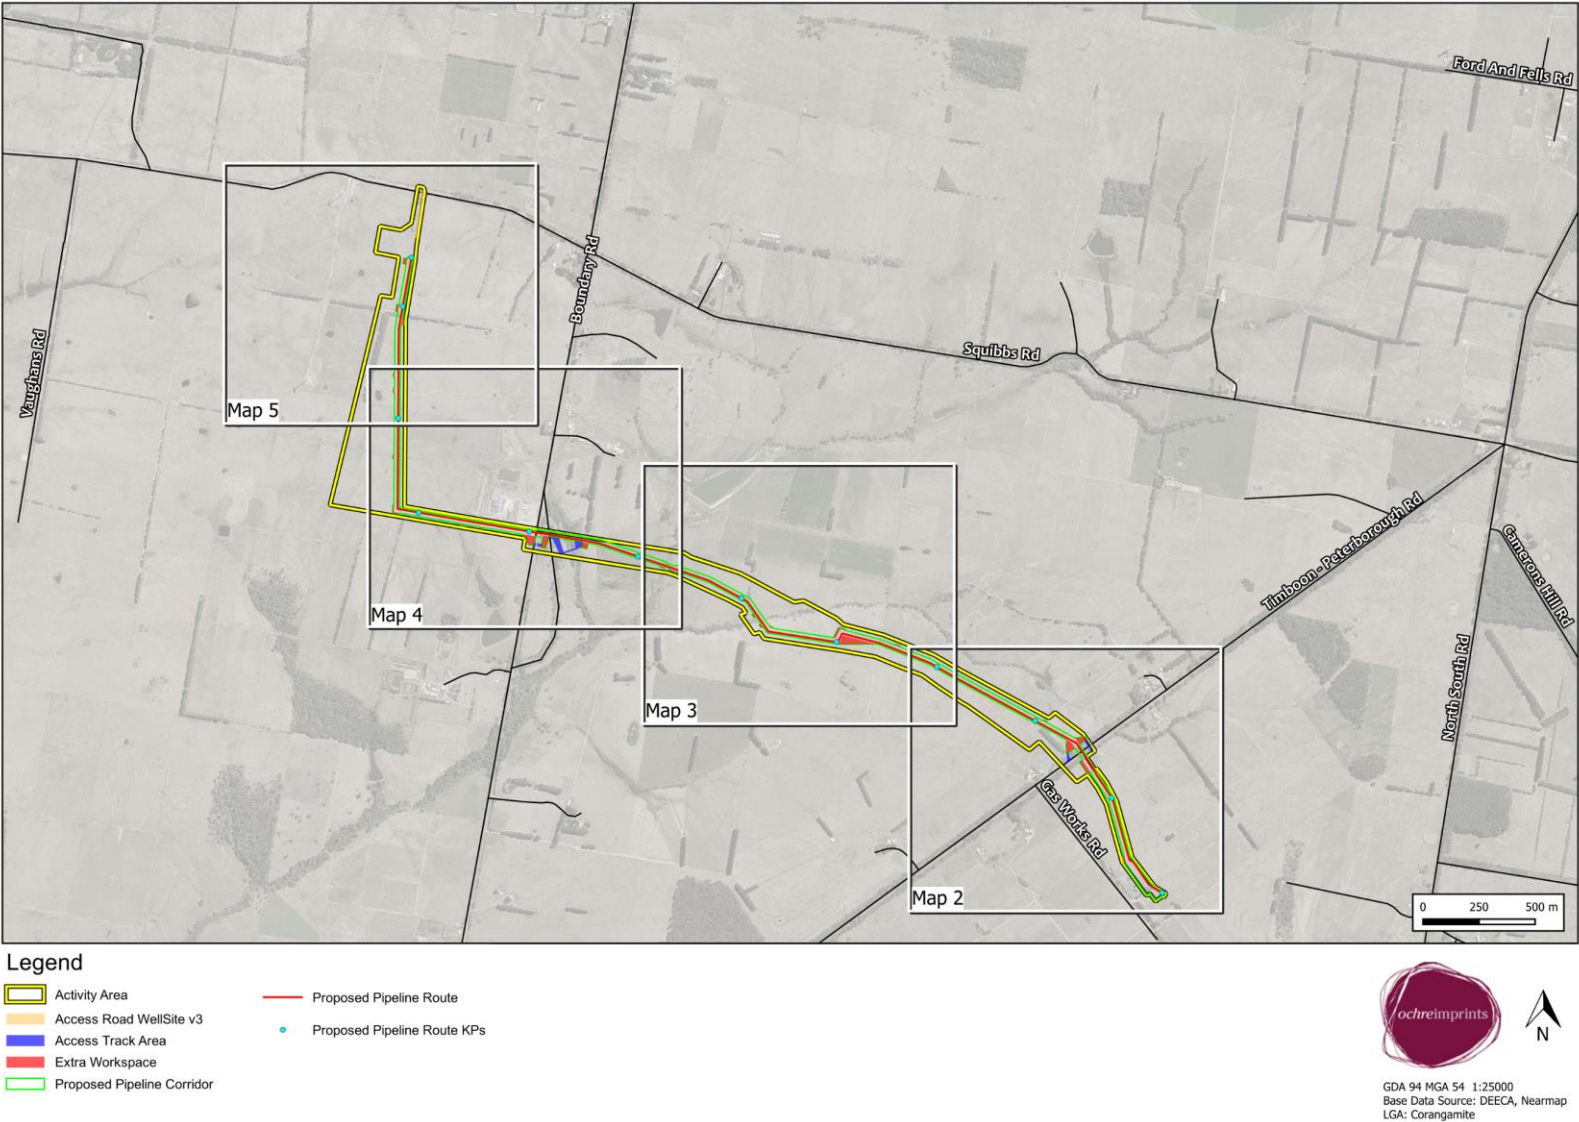
Figure 8: Development plan and proposed works area overview.

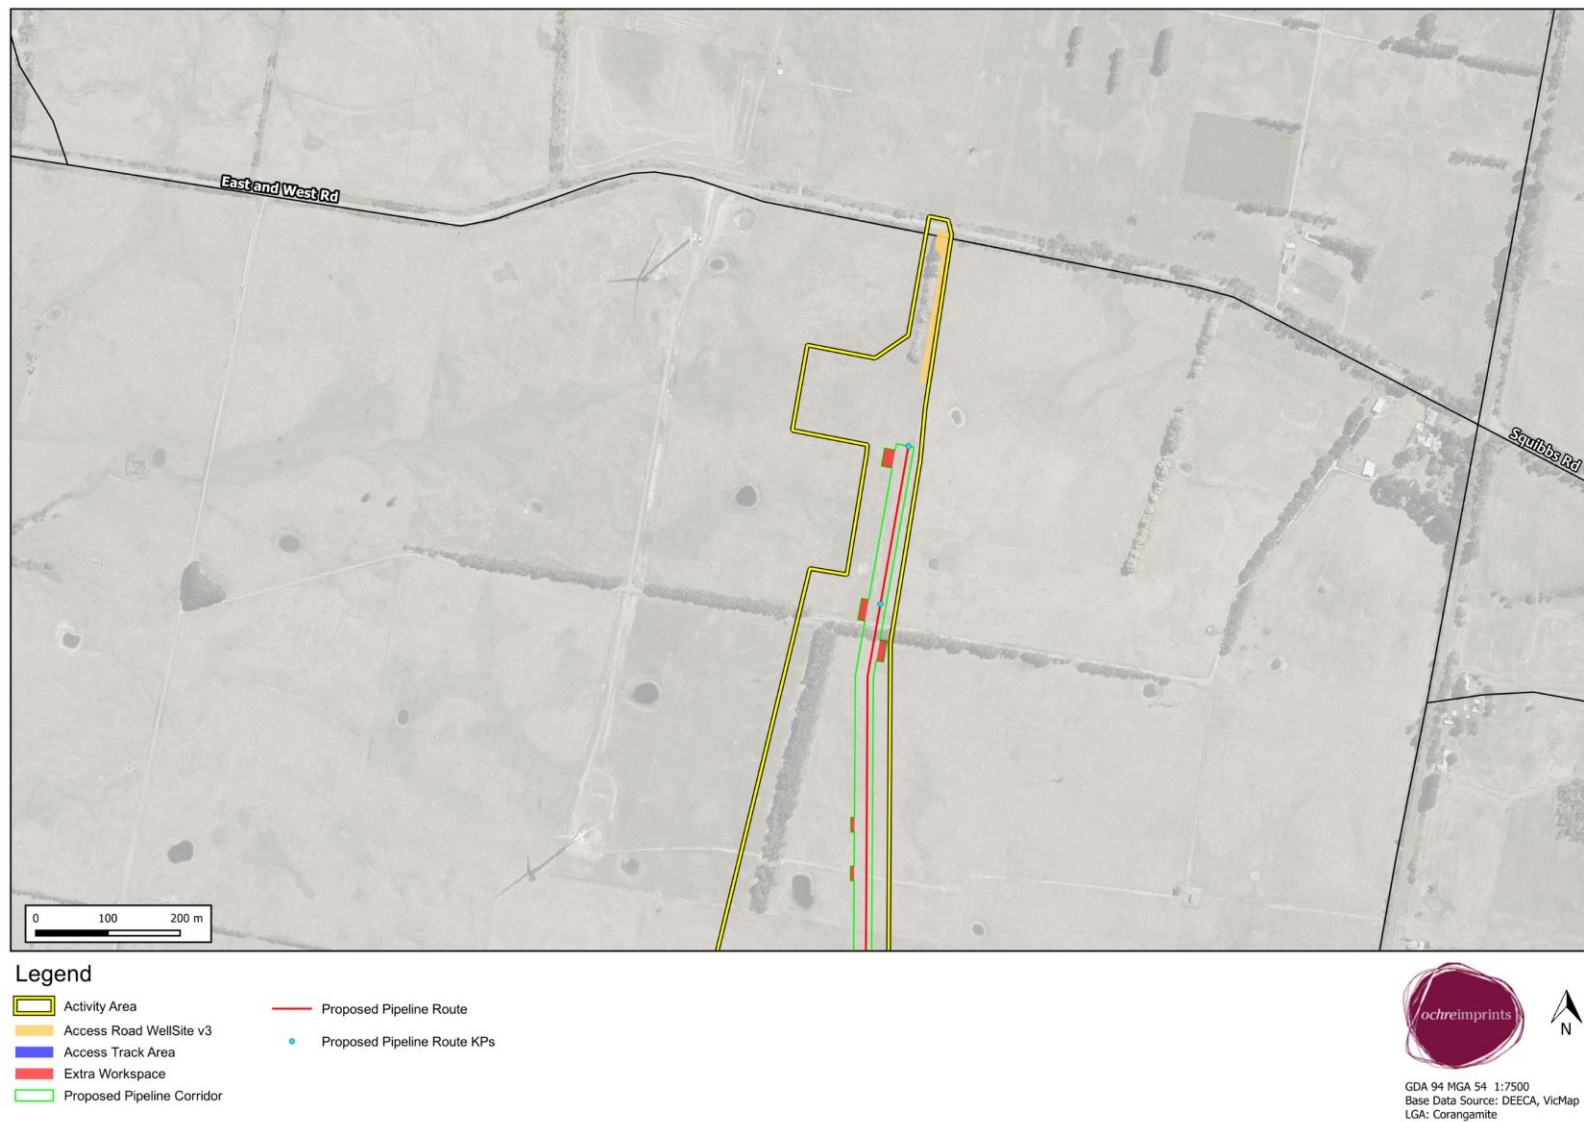
Figure 9: Development plan and proposed works area detail 1.

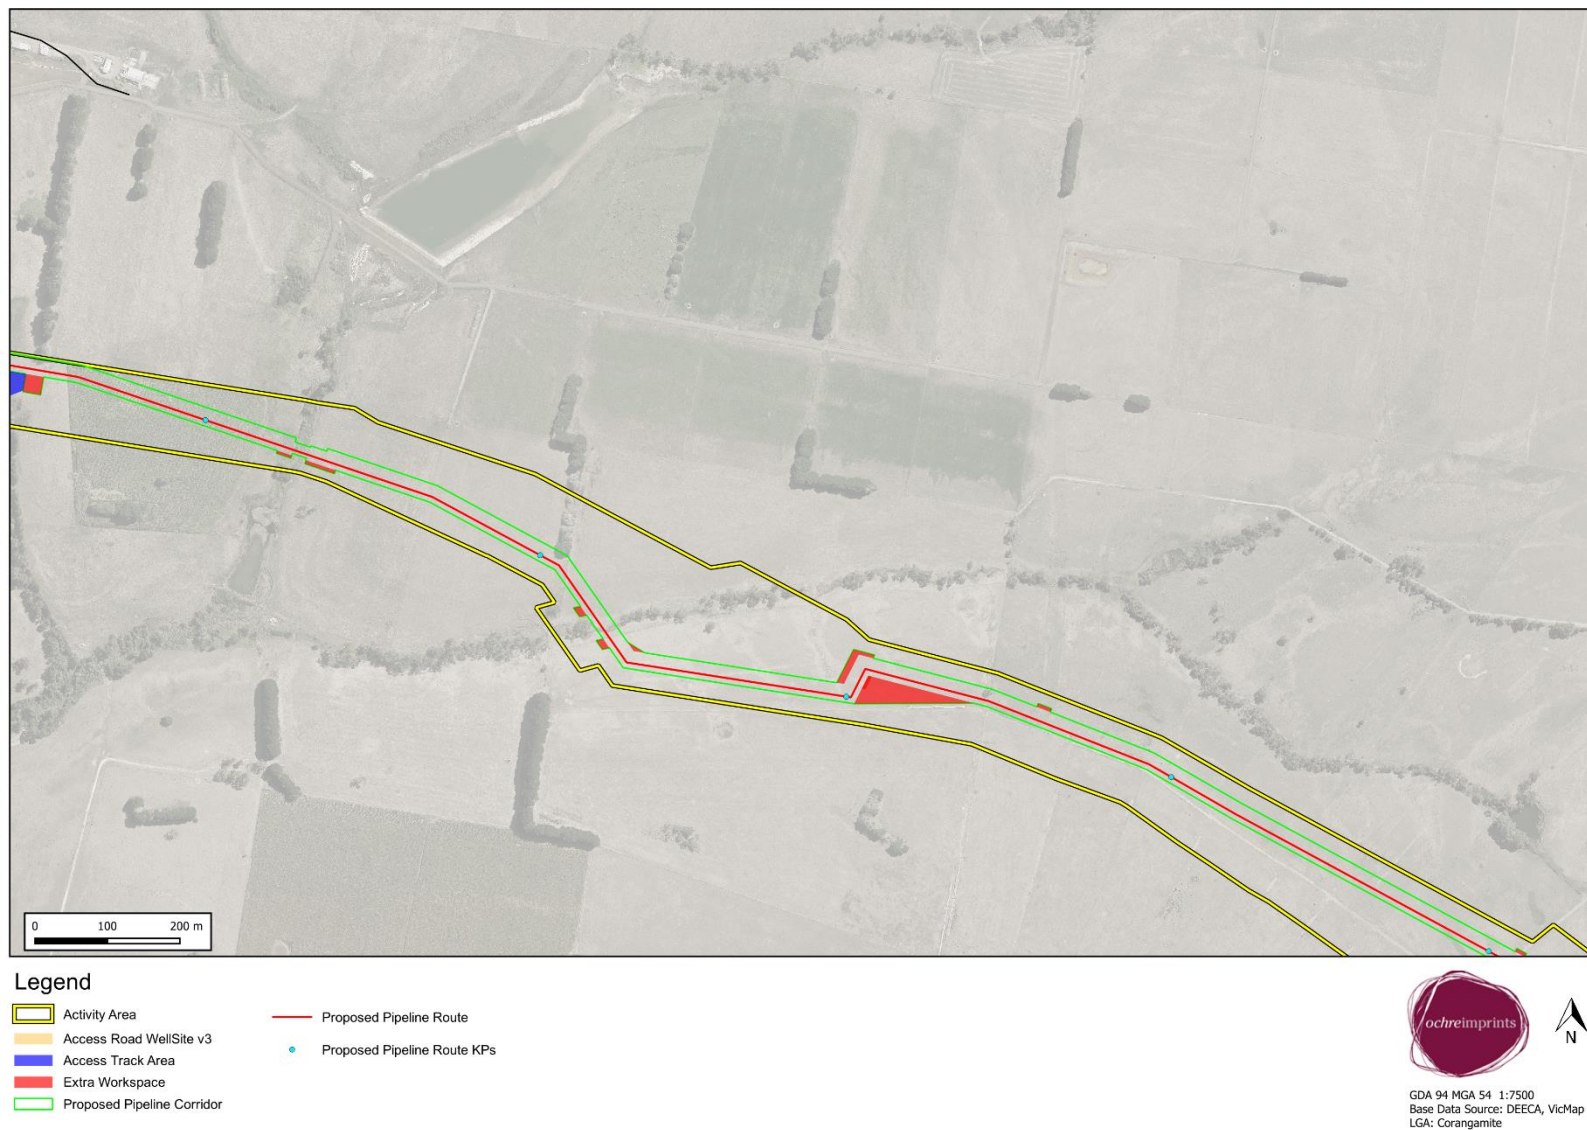
Figure 11: Development plan and proposed works area detail 3.

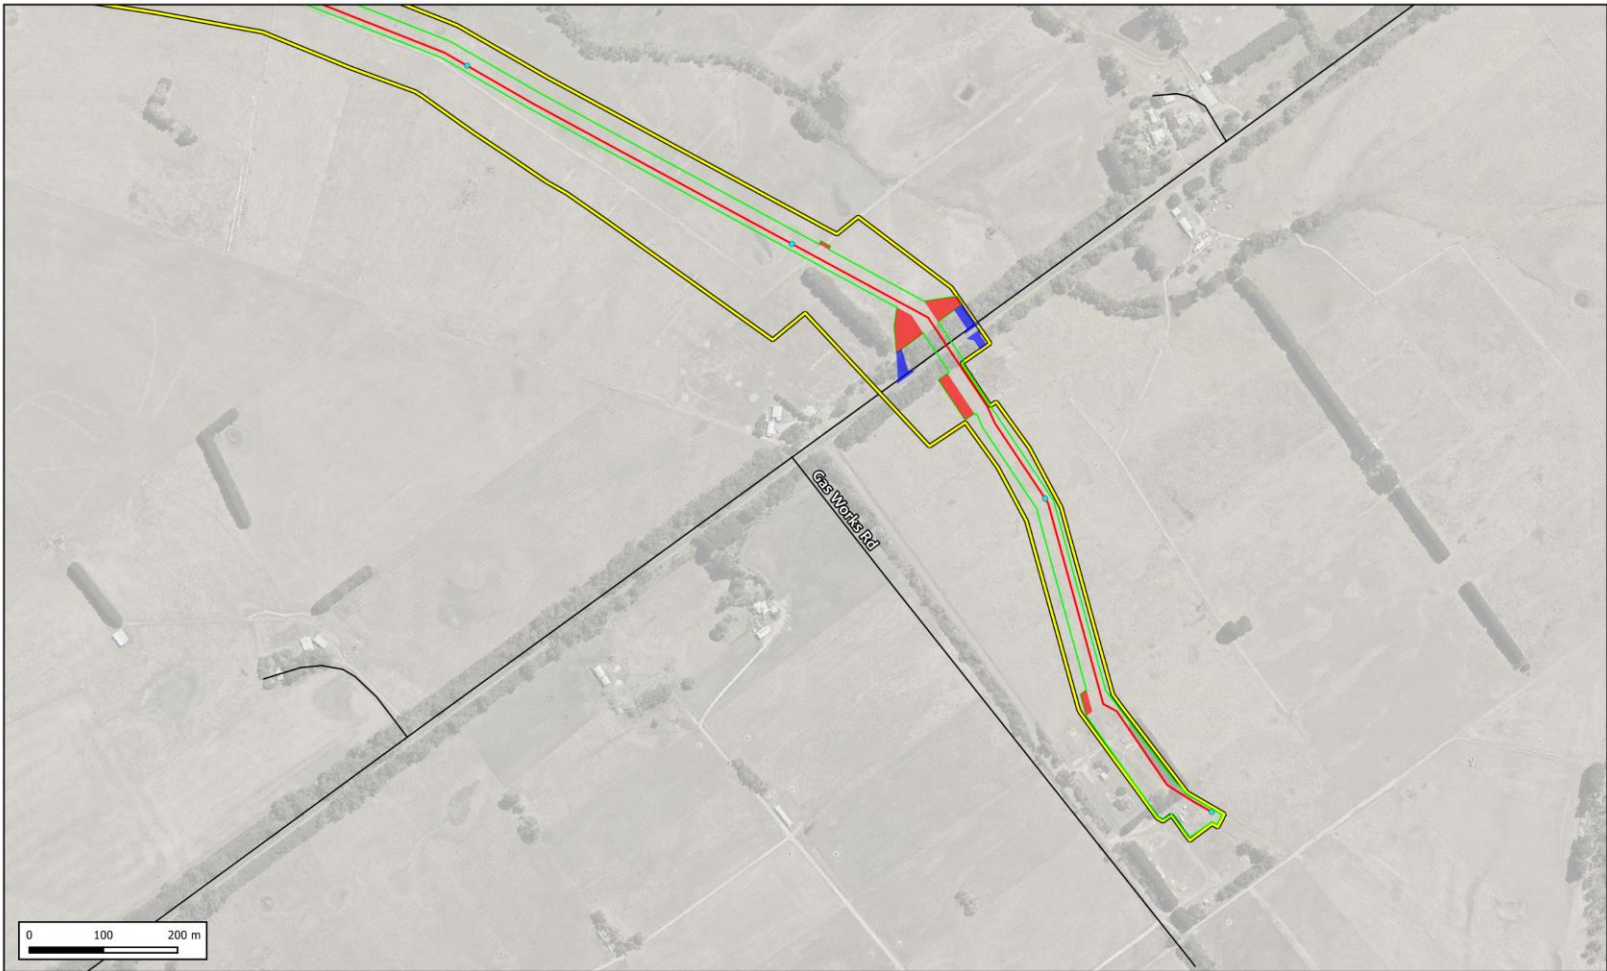
Figure 12: Development plan and proposed works area detail 4.

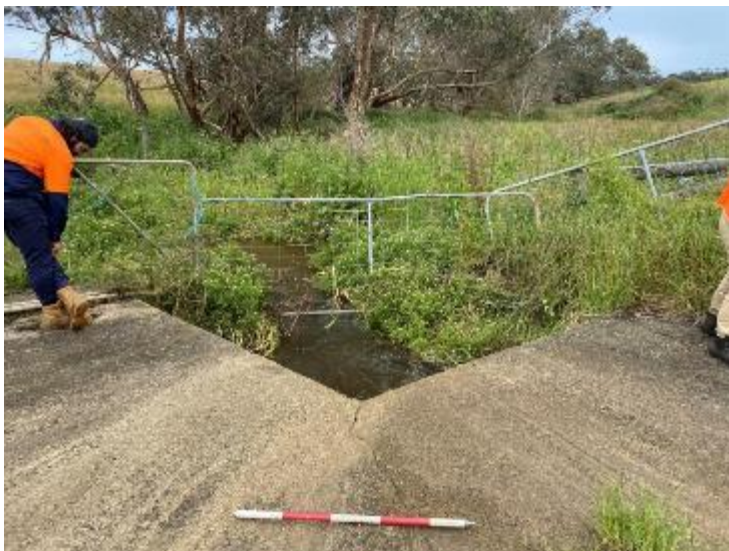
Plate 8: General area shot showing culvert on dissected plain landform (facing south).

Minor works contributing to ground disturbances include several culverts where Skull Creek and Leech Creek crosses the activity area. These were identified on the dissected plain landform (Plate 8-9). Paddock dividing fences also occur within the activity area on both landforms (Plates 10-11). Finally, land use for pastoral purposes has resulted in stock trampling occurring across the activity area (Plate 12).

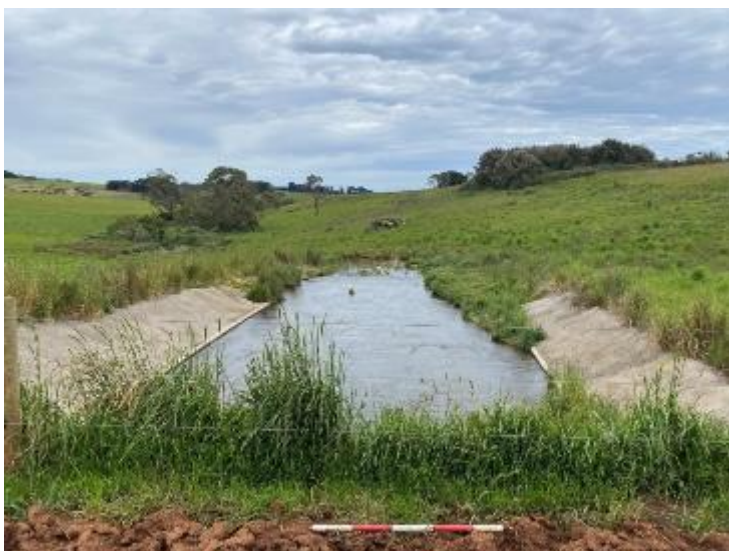
Plate 9: General area shot showing culvert on dissected plain landform (facing south).

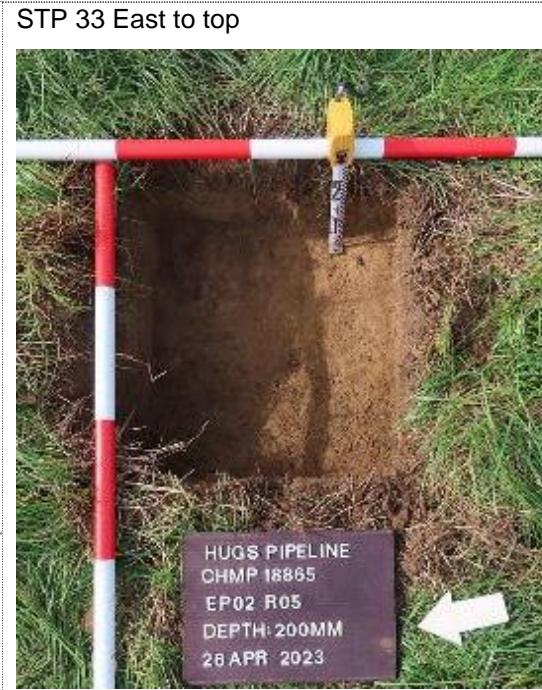
Table 8: Results of STP 33 (EP2 R05).

<p>Shovel Test Pit 33 (50 x 50 cm) Dissected Plain</p>	<p>Grid Reference GDA 94 MGA Zone 54 E 668484 N 5732120</p>
<p>Soil Horizons <u>0-100 mm</u>: Munsell 10YR 4/3 pH 6.0 Mid brown silty clay, friable, moist. Grass roots, insects, insect burrows. Charcoal flecks. <u>100-200 mm</u>: Munsell 10YR 5/6 pH 6.5 Mid brown-yellow clay, firm, moist. Ironstone fragments <u>200 mm +</u> Munsell 10YR 5/6 pH 6.5 Mid brown-yellow clay, compact, moist</p>	<p>Maximum Depth: 200 mm</p> <p>Disturbance: Grass roots, insects, insect burrows.</p> <p>Obstacles: None.</p>
<p>Aboriginal Cultural Heritage: 2 artefacts recovered from a depth of 0-100 mm.</p>

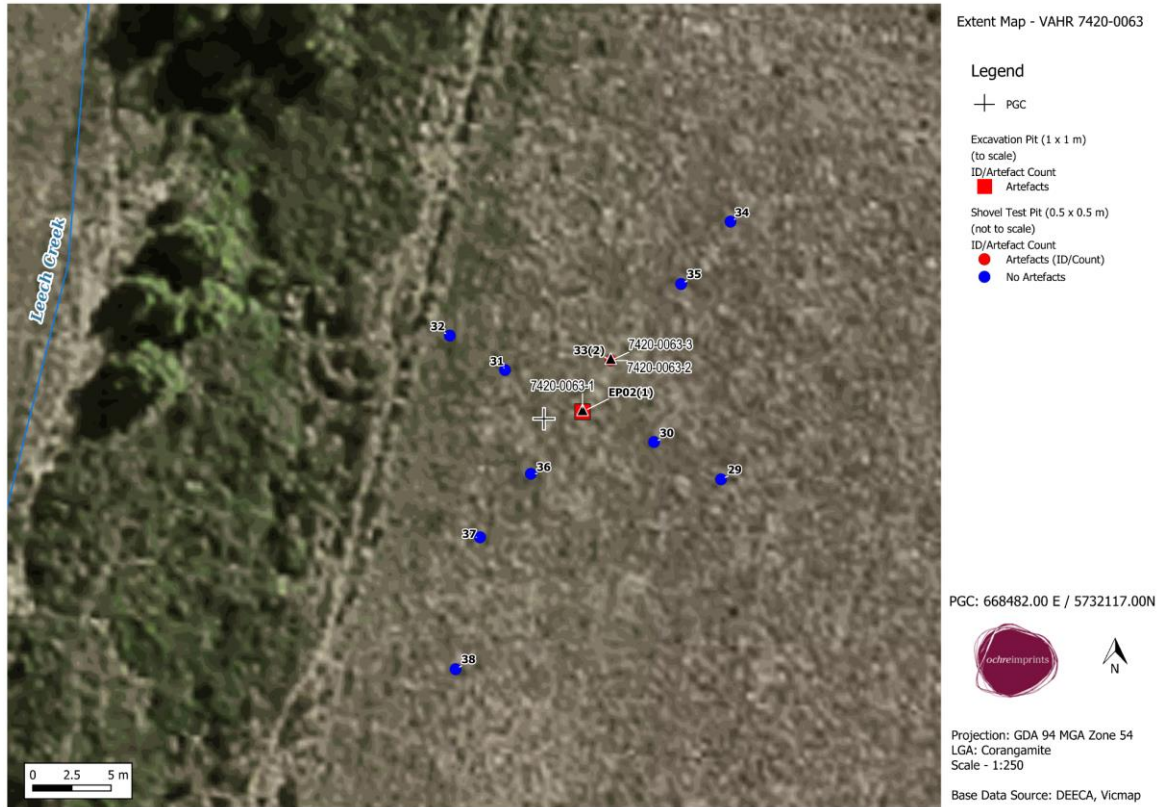
VAHR 7420-0063 site plan

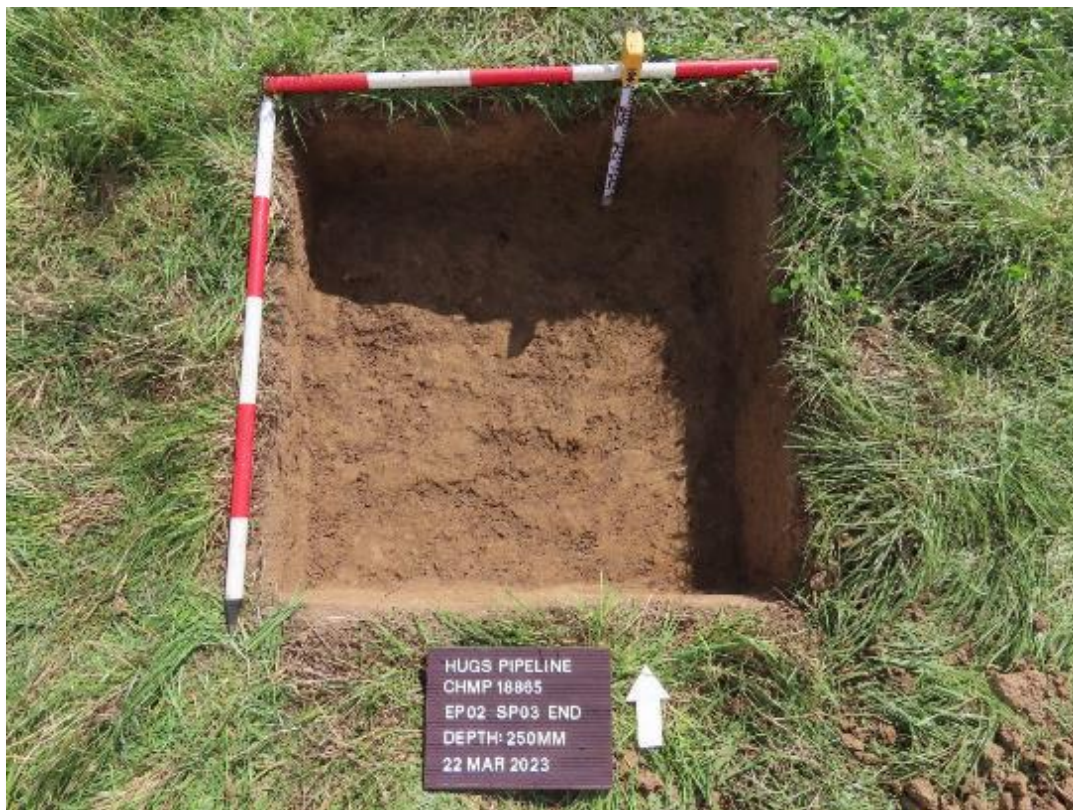
VAHR 7420-0063, EP 2 facing north.
